DEVELOPMENT OF COLUMBIUM ALLOY COMBINATIONS FOR GAS TURBINE BLADE APPLICATIONS

S. T. SCHEIRER
TRW Inc.

TECHNICAL REPORT AFML-TR-70-187

OCTOBER 1970

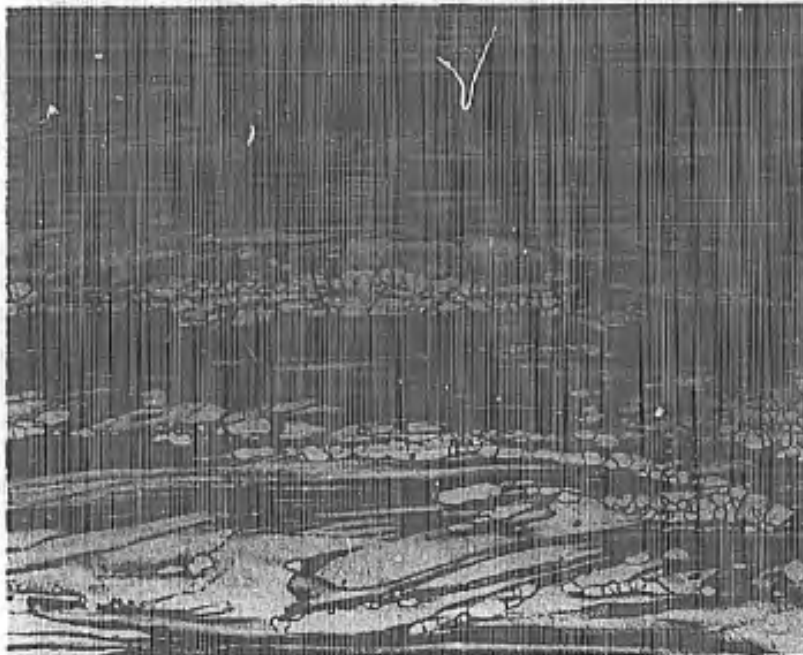
A. Heat No.
Vam 96A

Knoop HN=296
(100 gm load)

Knoop HN=309
(100 gm load)

Figure 3. Longitudinal microstructure of extruded VAM-79
(4:1 reduction at 3200°F), Heat No. indicated.
Magnification: 100X.

Photographs of four extrusions are shown in Figure 1 prior to sectioning, stripping, and machining for further processing. These products were of good quality, enabling a large percentage to be utilized. Microstructures of all 1 1/2" diameter extruded bar used in this program are shown, Figures 2, 3, and 4. (An etchant consisting of 64% H₂O, 15% HF, 15% H₂SO₄, and 8% HNO₃ was used for all metallography.) The higher degree of recrystallization evident in the TRW extruded Cb 132M, Figure 2a, is probably caused by a greater degree of heat retention due to the thicker molybdenum can. The other alloys, VAM-79 and SU-31, extruded at 3200°F and 2642°F respectively, exhibit very little or no recrystallization reflecting the lower working temperatures.

The microstructures of typical extrusions of the three alloys are shown at 100X, Figure 6. Upon comparison of this figure with Figures 2, 3 and 4, showing the microstructure of the 1 1/2" diameter extrusions, the additional amount of working is obvious. Hardnesses were correspondingly increased. The Cb 132M, which had the highest percentage of recrystallization in the starting material, is seen to have the least heavily worked structure.

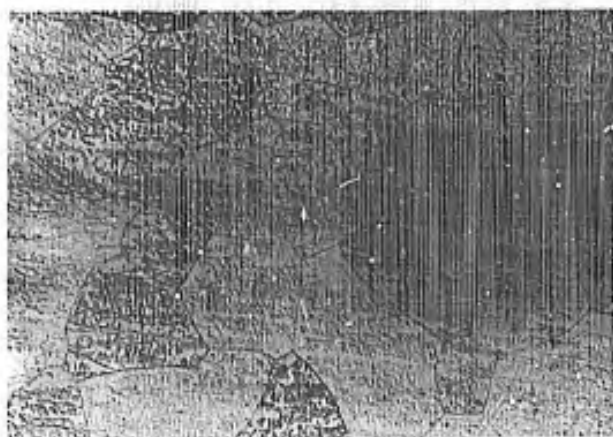
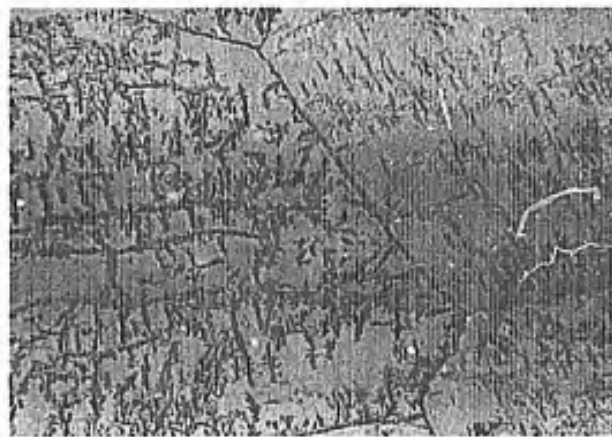
3200°F, 1 hour: Knoop hardness No. = 308

3600°F, 1 hour: Knoop hardness No. = 318

Figure 13. Microstructure of forged, annealed, and aged (2200°F for 4 hours) Cb 132M. Annealing temperature and magnification indicated. Heat No. M-497.

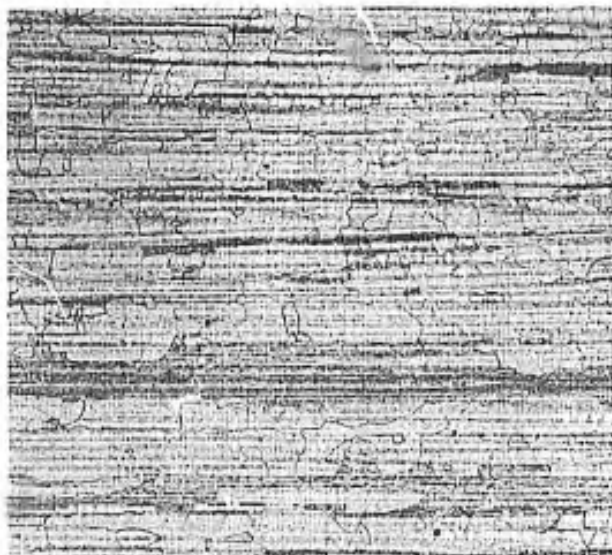
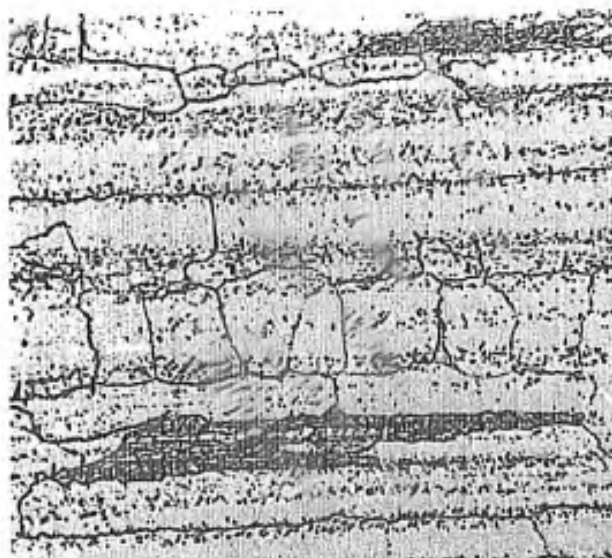
3000°F, 1 hour: Knoop hardness No. 281

3200°F, 1 hour: Knoop hardness No. = 271

Figure 20. Microstructure of forged and annealed SU-31. Annealing temperature and magnification indicated. Heat No. 17A.

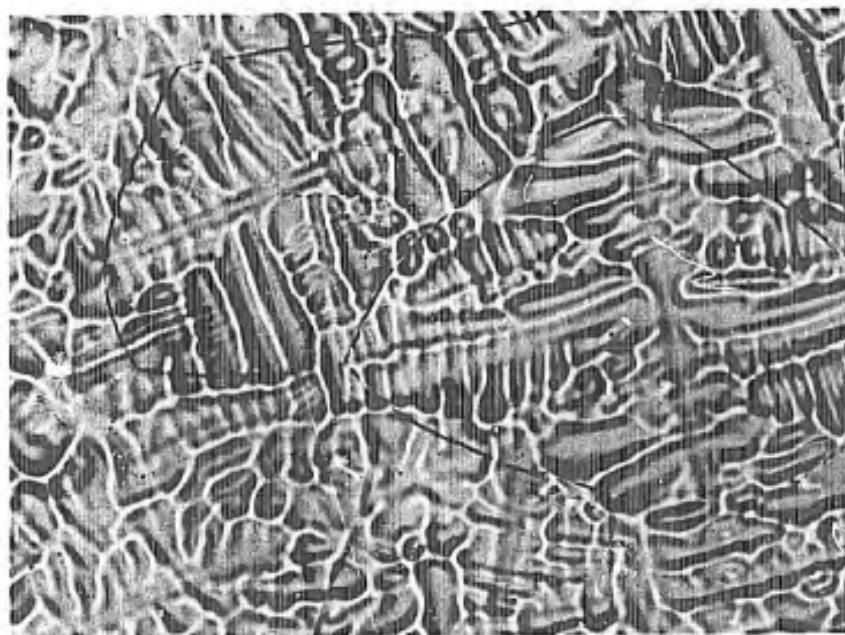
A. Alloy 1

B. Alloy 2

Figure 30. Microstructures of oxidation resistant alloys in the as-cast condition. Magnification: 150X.
